RELIABILITY IMPROVEMENT OF COOLING WATER PUMP

P. YOGESH¹, R. RAGHAVAN², R.VIGNESHKUMAR³,
R. HARISH⁴ & K. PRAVEENKUMAR⁵

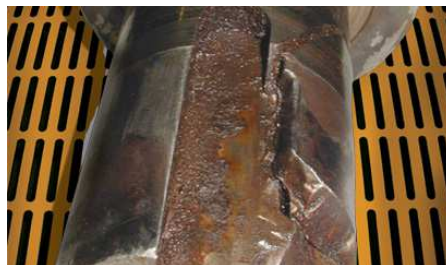
Figure 3: Failure Analysis of Machine Shafts

The failure mechanism due to corrosion at the juncture of both lock nut and shaft could be divided into 3 steps: Crack initiation, Crack propagation. Shaft sheared.

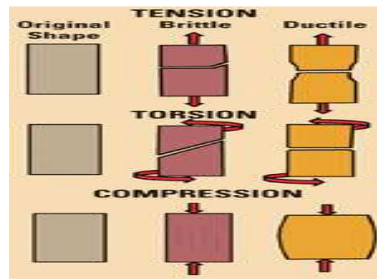
Figure 4: The Presence of an Over-Burden Disappointment Relies Upon whether the Pole Material is Fragile or Ductile

Over-burden disappointments are caused by the powers that surpass the yield quality or the elasticity of a material. As delineated in Figure 1, the presence of an over-burden disappointment relies upon whether the pole material is weak or flexible.

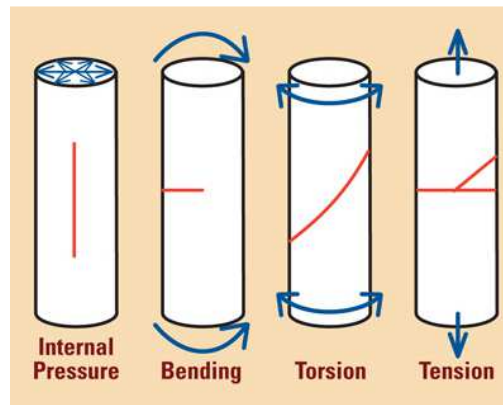
Figure 7: Fracture Planes caused by Four Common Fatigue Forces: Because the Section Properties will change as the Crack Grows, it'd Important to Look Carefully at the Point where the Failure Starts to Determine the Direction of the Forces

The condition or harshness of the crack surface is a standout amongst the most critical focuses to take a gander at in breaking down a disappointment on account of the distinction between over-burden disappointments and weariness disappointments. With over-burden disappointments—in light of the fact that the break goes at a steady rate—the surface is consistently unpleasant. Weakness A common plain twisting exhaustion disappointment is delineated in Figure 8. The split began at the starting point and gradually developed over the Fatigue Zone (FZ). When it achieved the limit of the Instantaneous Zone (IZ) the break development rate expanded colossally and the split traversed the IZ at around 8000 ft/sec. Amid the time of development over the FZ, there might be changes in the stacking on the pole, which result in changes in the surface that show up as movement marks.
